# A Multiscale and Multimethod Approach to Assess and Mitigate Concrete Damage Due to Alkali–Silica Reaction

Frank Weise,\* Julia von Werder, Tanja Manninger, Bärbel Maier, Matthias Fladt, Sebastian Simon, André Gardei, Desirée Hoehnel, Stephan Pirsawetz, and Birgit Meng

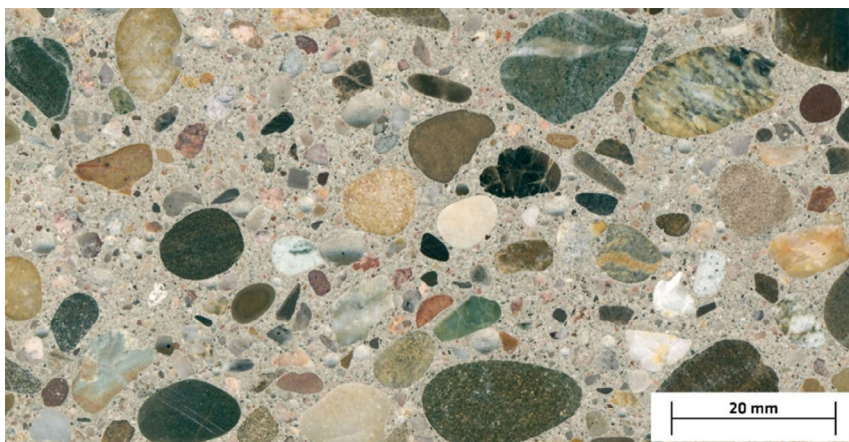
**Figure 1.** Typical concrete meso/microstructure: aggregate made of multicomponent river gravel, solidified by a cementitious binding matrix (mineral phases of micro- and nano-size, composed of relicts of the original binder and filler components and their multiphase reaction products resulting from their reaction with water).

of hardened concrete on the mesoscale are grains of aggregate embedded in a micro–nanostructured matrix, as shown in **Figure 1**. A wide range of natural or synthetic stones can be used as coarse or fine aggregate. The binding matrix is usually formed by hydration reaction of a cement with water, modified with other mineral additions and further admixtures, each of them in hundreds or even thousands of possible variations.<sup>[3,4]</sup>

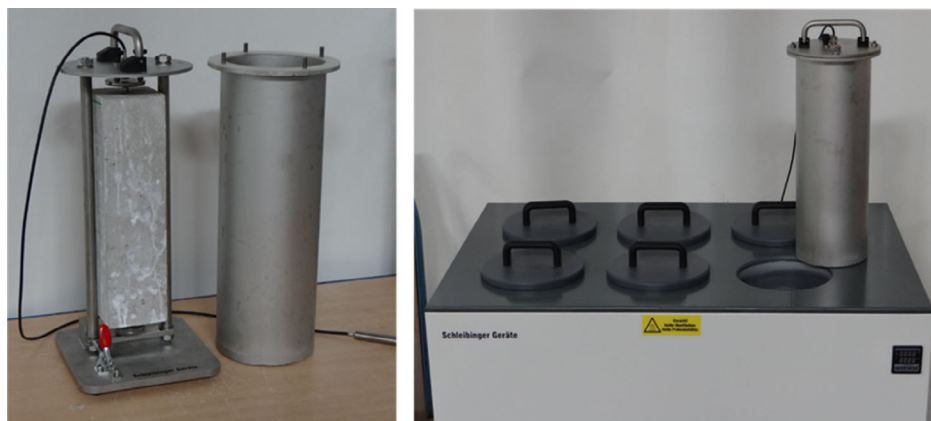
**Figure 12.** Specimen (75 mm × 75 mm × 280 mm) in a measurement frame and the container (left), and benchtop reactor for six specimen containers (right). Adapted with permission.<sup>[87]</sup> Copyright 2019, Ernst & Sohn.
