INFRARED THERMAL IMAGING AS A NON-DESTRUCTIVE INVESTIGATION METHOD FOR BUILDING ARCHAEOLOGICAL PURPOSES

KEY WORDS: Infrared Thermography, IR thermal imaging, Building Archaeology, Heritage Conservation, NDT Monitoring

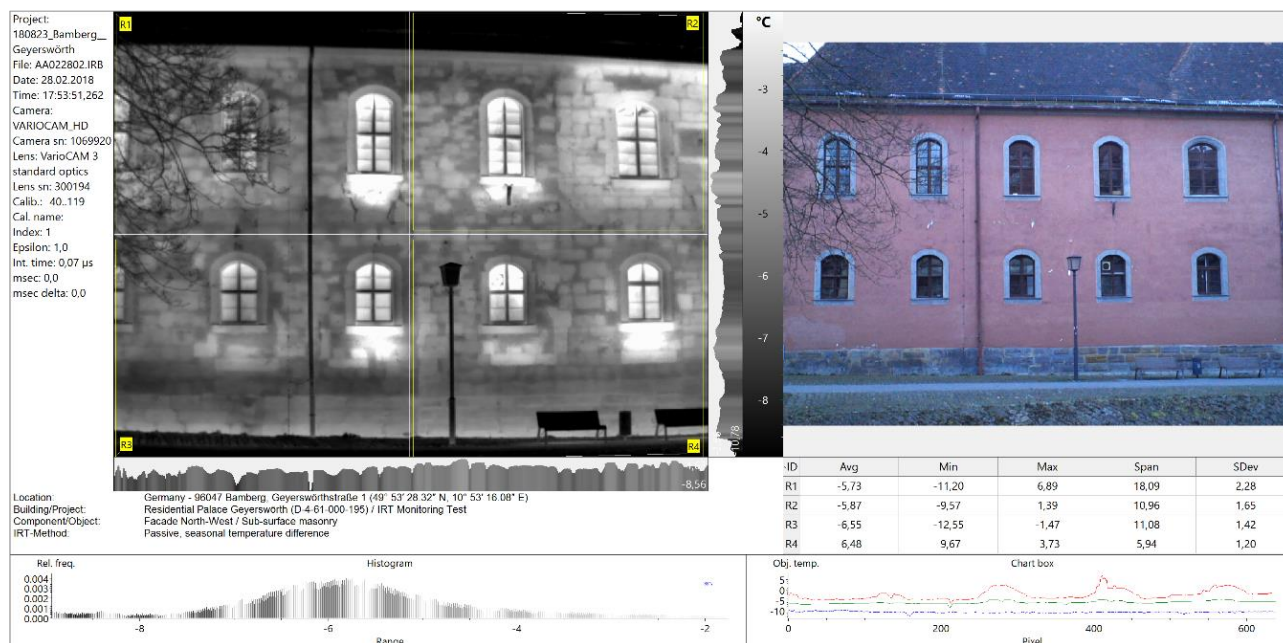
Figure 1: Greyscale visualisation of radiometric information, depicting thermal distribution, variations and anomalies in temperature values.

The thermogram (Fig.1) depicts a section of the northeast façade, displaying sub-surface structures with varying joint network, alterations of building structures and stone replacements. The post processing illustrates these façade parts' radiometric data in three versions: V1 (Fig.1: Greyscale visualisation of temperature values) depicts optimal imaging contrasts, hence improving the visibility of distinctive differences in materiality. V2 (Fig.2: Greyscale + red marker visualisation) marks thermal inhomogeneity, outlining regions with the highest temperature values. V3 (Fig.3: Merging of thermal and visual image) locates the extent and position of the radiometric data and provides a framework for mapping thermal infrared information onto visual images. For deducing Building Archaeological findings, Version 1 illustrates the most distinct thermal features and therefore the most precisely detailed information. Greyscale-imaging with a colour count of 1000 values and a moderate linearity yielded the best contrasts, far better than the common all-colour version.

Data evaluation therefore always comprises the visual image of the radiometric data combined with a relating temperature scale, temperature profiles, histogram, parameter setting list, column value chart and profile chart. (Fig. 1)

The same holds true for regions of material damage or decay. The area below the right window in R1 exemplifies a structural injury in the masonry. (Fig.1) Two funnel-shaped cracks can be seen running from the upper to lower window. In visible wavelengths, they would only be detectable if a very detailed mapping was conducted. In the case of cracks underneath plaster, IRT is capable of displaying the extent and distribution of both structural and material-related degeneration forms. The radiometric examination reveals distinct disruption of the heat transition on the edges of crack lines. This disruption makes the crack lines appear more prominent, thus enhancing the recording of damages for Building Archaeological assessments. From that depiction, even conclusions regarding structural forces exceeding the fabric's potential are verifiable. The same holds true for water ingress, salinization and abrasion, all of which result in local thermal anomalies.

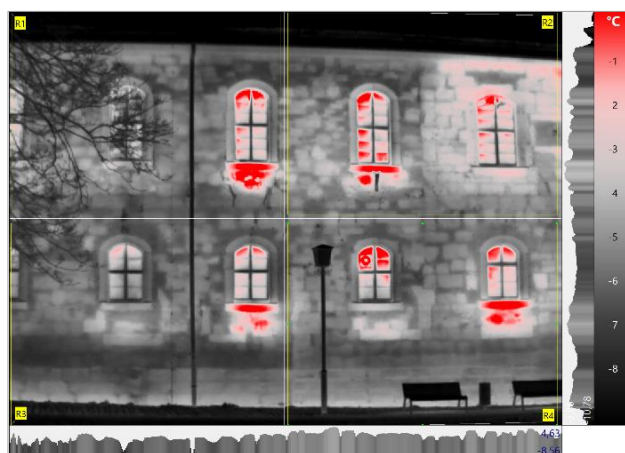
Figure 2: Greyscale and red marker visualisation. Focus on regions with highest temperature values.

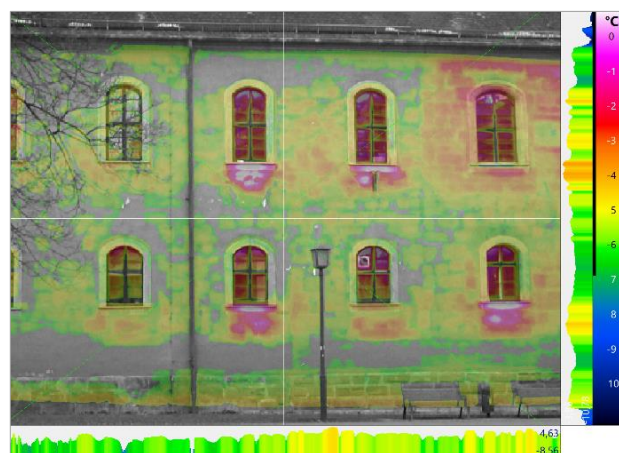
Figure 3: Merging of thermal and visual image. Location of the extent and position of the radiometric data.

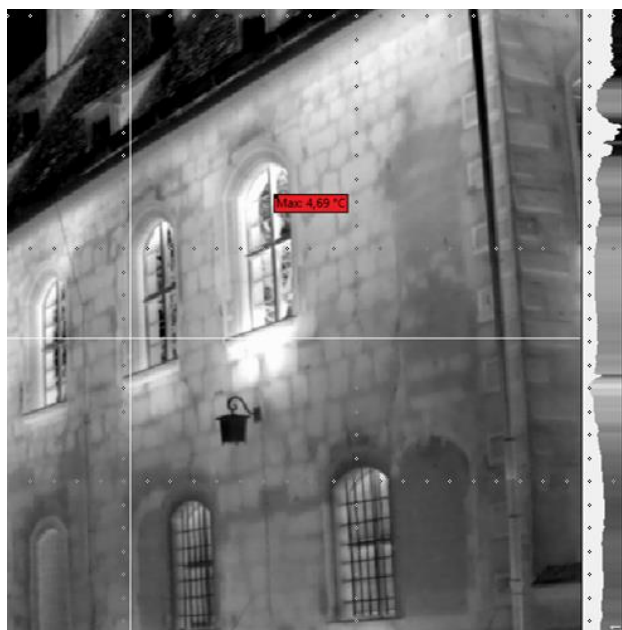
Figure 4: Greyscale visualisation of subsequently walled up openings under plaster.

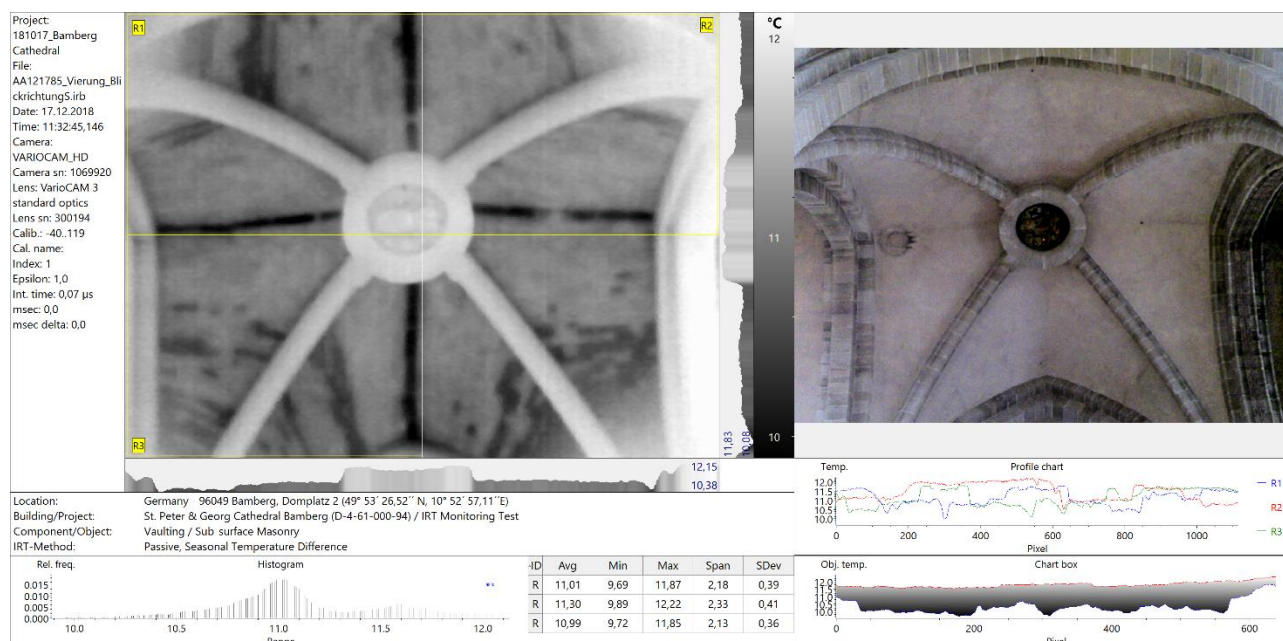
The vaulting structure over the crossing of transept and aisle corresponds to that of a cross-ribbed vault with pointed arches, bounded by similar transverse ribs on all four sides. (Fig. 5) The diagonal ribs cross in a circularly edged oculus. Both longitudinal and lateral ridge lines finish at the oculus as well. While the vaulting webs are plastered and painted, the oculus, diagonal and transverse ribs remain untreated. Their radiometric examination clearly depicts varying masonry and mortar joint features. The ridge lines show significant alterations in stone size and fabric and the thermal emission of those stone lines clearly differentiates them from the enclosing vault severe stones, hinting at different thermal properties and therefore stone material.

Variations in heat capacity directly correlate to stone fabric in this case. Displaying a very distinct thermal behaviour, the masonry elements used must belong to different stone types. Deductions from this information enables further Building Archaeological conclusions: As their positioning corresponds closely to the vaulting's ridge line, they apparently correspond to a superordinate constructive purpose. Further evidence visible in the thermogram is the larger size of those ridge line stones and their continuous and regular positioning. This is possibly due to the historic construction process. The ridge line stones could have been part of a stabilising sub-structure for the web's vaulting process. Additional investigations on their material properties could provide more detailed information on their structural relevance. Furthermore, the changing stone fabric towards the vault's gussets is noticeable. Following down the cross-ribs, each

Figure 5: Greyscale visualisation and radiometric measurements of the vaulting structure over crossing of transept and aisle, depicting masonry construction, variations in fabric, stone sizes and pattern.

of the four gussets appears significantly darker and therefore colder or thermally inert regions in the thermogram.

These regions encompass the size of single stones or the masonry bonds of several stones with radiometrically detectable joint runs. Such distinct thermal capacity clearly hints at alterations in stone material. In contrast to the stone bonds in the ridge line, those thermally prominent in the gussets do not display a coherent distribution or thermal bond. Comparing each gusset, their number, position and allocation varies from gusset to gusset. However, all the stone alterations only reach halfway up the rib line towards the oculus. This might be a result of both the vaulting's construction process and the stones' constructive purpose as possible bracing elements of the gussets. All things considered, the configuration of masonry and joints visualised in the thermogram allows differentiated conclusions on the vaulting process.

Deducing from their irregular distribution, a later insertion of those stones, for example due to repair works, seems unlikely. Their consistent sizes also correspond to the surrounding masonry. In this case, further evidence from supplementary Building Archaeological examinations is needed to verify the theories mentioned above. IRT alone has outlined the findings, but the multicausal deductions require further detailed diagnostic methods, and an in-situ assessment of the vaulting structure.

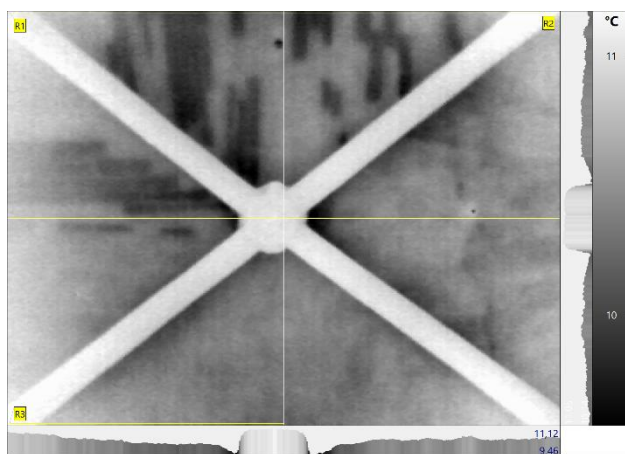
The vault in the second bay displays comparable radiometric features. (Fig.6) Several vaulting web stones appear significantly darker in the thermograms, they have a lower temperature and are therefore thermally more inert. These occur mainly in the western and southern web, with a few also in the northern part of the vault. The eastern web does not show any radiometric anomalies. The amount, distribution and configuration of the more inert masonry variations differ from web to web. Even stone size varies.

Figure 6: Thermogram of the plastered masonry vault in bay two. depicting joint structure, stone dimensions and variety of material characteristics.

In contrast to the crossing vault's thermal image, which enables clear conclusions on construction connections, the thermogram of the side aisle vaulting, whilst of the same radiometric quality and precision, is in this case only suitable as a basis for the discussion of Building Archaeological construction possibilities. Supplementary examinations of the vault are required to support theories on the vaulting's construction, possible replacements and repair works. The vaulting configuration's irregularity in fabric speaks against a constructive coherency or a specific structural purpose. Explanations for the stone variation must therefore be supplemented with research on material parameters

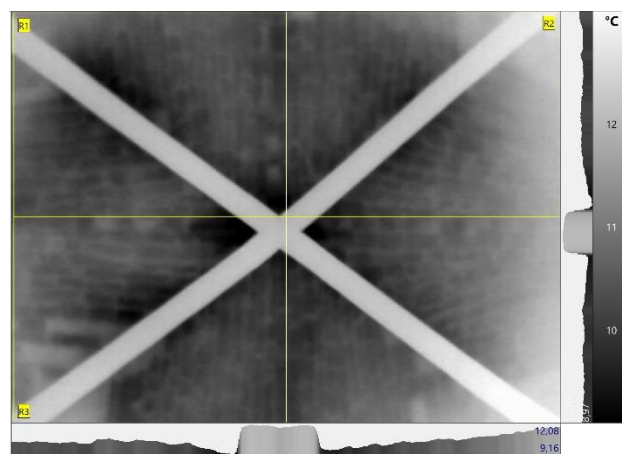
The thermogram of the eighth bay shows the highest amount of the thermally more inert stone fabric variety. (Fig.7) Apart from the lower part of the gussets, almost every part of the web consists of the radiometrically inert stone type, which appears darker in the thermal image. These vaulting stones are of smaller size and denser masonry bonds than the thermally comparable examples in the other vaults. While they evince a homogenous masonry configuration over the four webs, the stone variations in the gussets display irregular forms and layout in every web.

Figure 7: Thermogram of bay eight with the highest amount of thermally more inert stone fabric variety.

As these are singular records, it seems unlikely that this vaulting structure belongs to the original vaultings. There is no apparent constructive reason that justifies bay eight consisting of a completely different vault fabric. Although they are almost identical in size and height, neither bays one to seven in the southern side aisle nor the bays in the northern side aisle have any comparable features. This suggests that the differences in bay eight must be the result of changes due to a later restoration processes. The unusual stone alterations are further detectable in the ridgelines: All four of them consist of one row of alternating stone types with slightly larger dimensions than the enclosing web masonry. Those findings are comparable to the crossing vault's ridgelines. Thermal imaging can therefore be a suitable framework for investigating radiometric similarities and differences of comparable building structures.

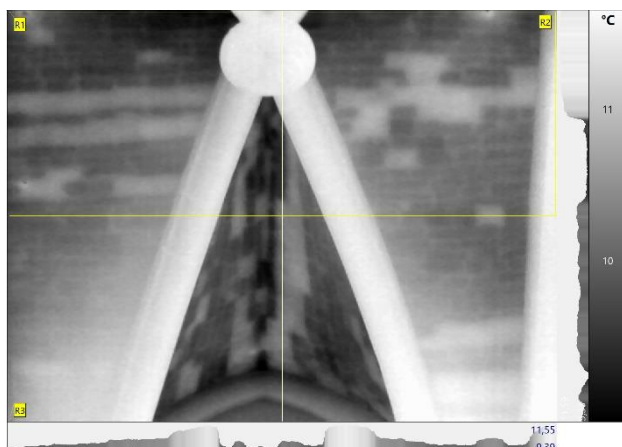
The thermogram of the southern transept's vaulting displays another variation in the masonry structure. (Fig.8) Their configuration corresponds to a rectangular layout half the size of the crossings square, vaulted with cross-ribs. Due to their narrower proportions, the pointed arches are higher, and their ridgelines more distinctly built.

The masonry bonds differ from web to web. All of them appear to be quite heterogeneous with large parts of the thermally more inert stone type and irregularly positioned stone variations that appear brighter and therefore less inert in the thermograms.

Figure 8: Thermogram of the southern transept's vaulting with heterogeneous masonry pattern.

Compared to vaults examined previously, the transept vaultings display a broad variation of stone sizes. The more inert stone type mainly comprises smaller forms with A few larger components running along individual joint lines. The larger, less inert stone types sometimes form rows, predominantly next to the gussets and ridgeline. In this case, superordinate constructive purposes could be the reason for their layout.

But they also appear as single vaulting components, especially in the narrower webs in the east and west. Their layout does not reveal any distinct pattern.

Both a random variation in vaulting fabric due to material availability or later exchanges and repair works could be possible explanations. However, while IRT provides the initial radiometric examination that generates a standardized mapping of material features, constructive configurations and thermal anomalies, any building archaeological theory needs additional examinations of joint lines, material analyses and comparative studies of vaulting techniques. IRT provides the initial radiometric examination that generates a standardized mapping of material features, constructive configurations and thermal anomalies.
