1 UAV-enabled reconnaissance and trajectory modeling 2 of a co-seismic rockfall in Lefkada

18 The paper presents the field evidence and the kinematical study of the motion of a 19 rock block mobilised by an earthquake-induced rockfall in Ponti area in the island of 20 Lefkada during a M_w 6.5 earthquake on 17th November 2015. A detailed field survey 21 was deployed using an Unmanned Aerial Vehicle (UAV) with an ultra-high definition 22 (UHD) camera, which produced a high-resolution orthophoto and a Digital Surface 23 Model (DSM) of the terrain. The sequence of impact marks from the rock trajectory 24 on the ground surface was identified using the orthophoto and verified through a 25 detailed field survey. Additionally, the earthquake characteristics were determined in 26 order to define the acceleration on the rock slope and the initial conditions of the 27 detached block. Using the impact points from the actual rockfall trajectory, an 28 analytical approach to reconstruct the trajectory was implemented, which led to some 29 insights on the coefficients of restitution. In order to match the actual trajectory, 2D 30 and 3D rockfall analyses were performed using the recommended set

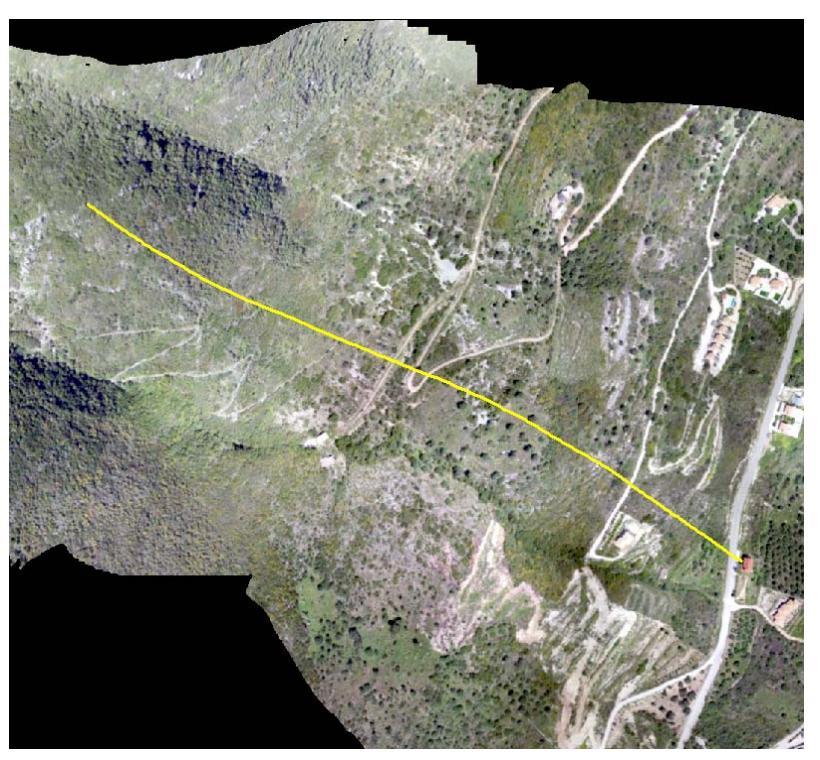
Figure 1. Orthophoto of study site showing known trajectory and impact on house.

The slope overhanging Ponti village is formed in limestone and has a maximum height of 600 m and an average slope angle of 35[°] to 40[°] (Figure 1). The geological formations at the Ponti rockfall site are limestones covered by moderately cemented talus materials. The thickness of the talus materials ranges between 0.5 and 4.0 to 5.0 m. A few fallen limestone blocks were identified on the scree slope, with volumes between 0.5 and 2 m³. Based on the size distribution of these rocks on the slope, the average expected block volume would be in the order of 1 to 2 m³.

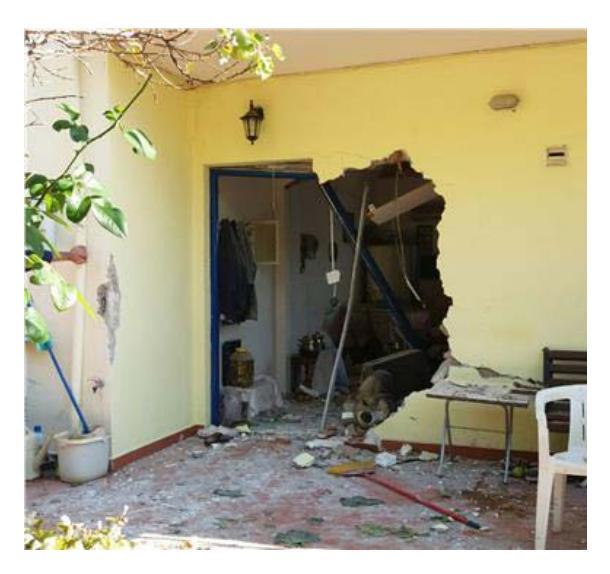
Figure 2. Impact of rock on house in Ponti, Lefkada, Greece.

- The rockfall release area was at an elevation of 500 m, while the impacted house at an elevation of 130 m (Figure 2). The volume of the detached limestone block was approximately 2 m³ and its dimensions equal to 1.4 m x 1.4 m x 1 m. There was no previous rockfall incident reported for the specific slope that impacted the road or house.
- 88 3. UAV mapping

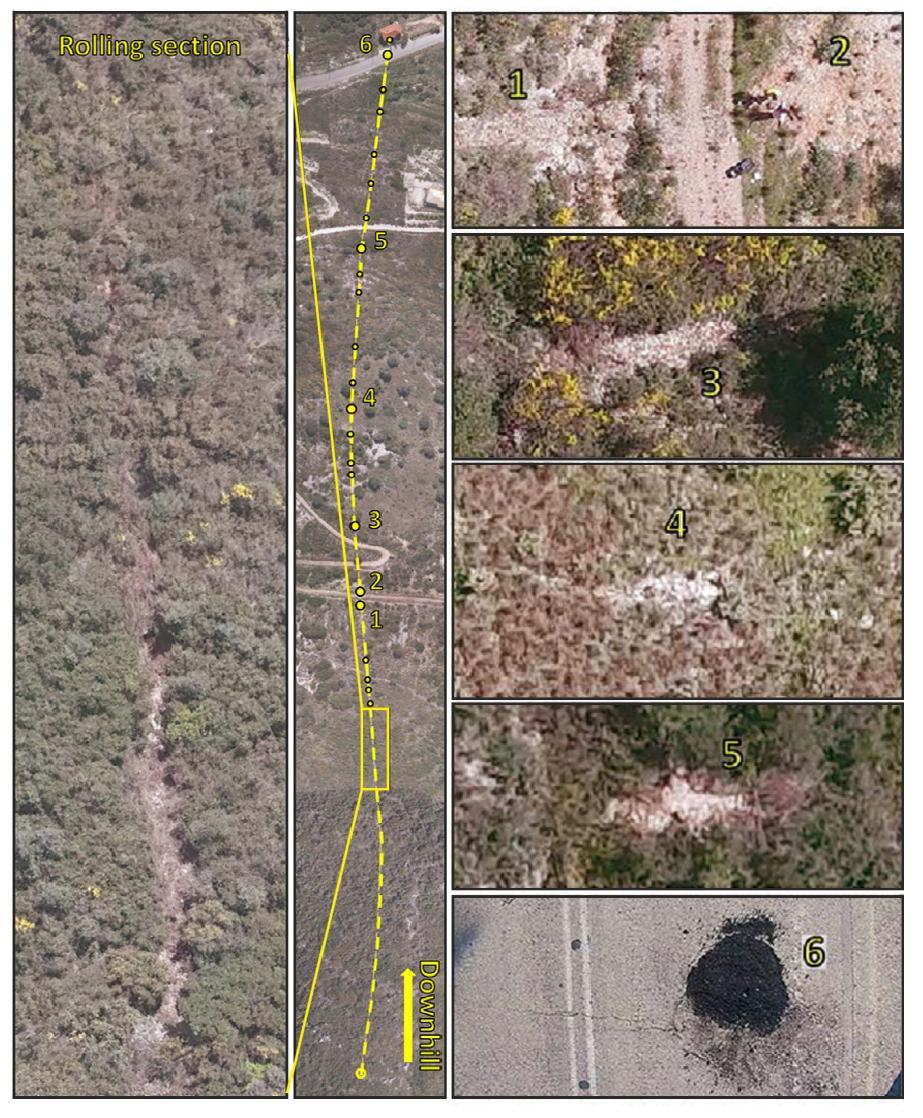
Figure 3. Top view orthophoto denoting rolling section, bouncing positions and closeups of impact points.

113 A 5cm pixel size orthophoto was generaated based on thhe methodology outlined 114 earlier. As showin Fig. 3, the rolling section and the bouncing locations of the rock 115 block throughou its course were identified. The rolling section is discerned as a 116 continuous and largely linear mark left in the densely vegetated terrain that is 117 indicative of the damage caused. Impact points that are part of the bouncing section 118 of the rock, are identified as circular to ellipsoidal bare earth craters with no 119 disturbance in between. The last bouncing point before impacting the house is clearly 120 identified on the paved road. The plan view ortho-imagery, along with the original 121 footage of the video collected was crucial to the qualitative identification of these 122 features. The alternative, i.e., land-based, conventional field reconnaissance was 123 practically impossible tto perform in the the densely vegetated and steep terrain.

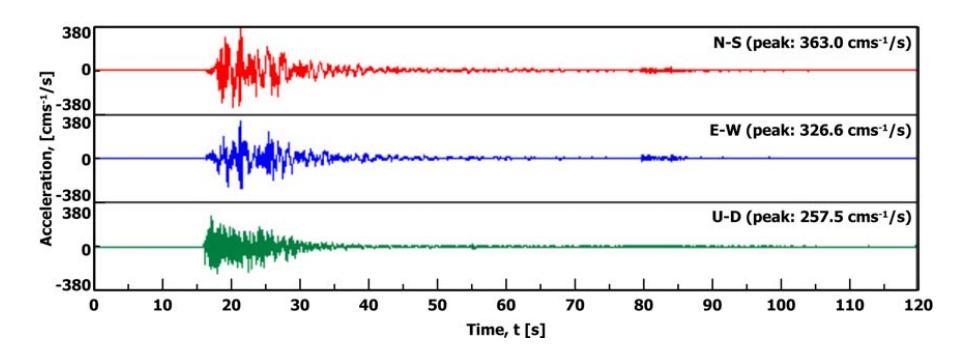
Figure 4. Acceleration recording at Vassiliki site (ITSAK, 2016)

A strong motion station recorded the ground motions in the village of Vasiliki located at a distance of 2.5 km from the site. The ground motion characteristics of the recording are summarized in Table 1 and are presented in Figure 4, according to an ITSAK preliminary report (ITSAK, 2016). In comparison with the recordings at other locations in Central Ionian, it was evident that the strongest acceleration was encountered in Vasiliki area.

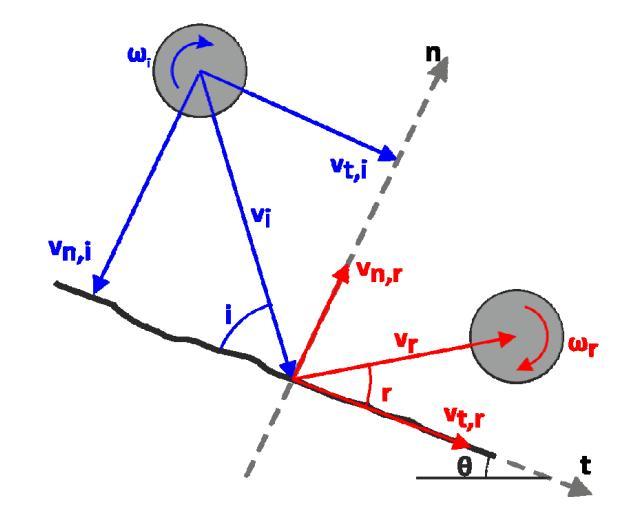
Figure 5. Coefficients of restitution

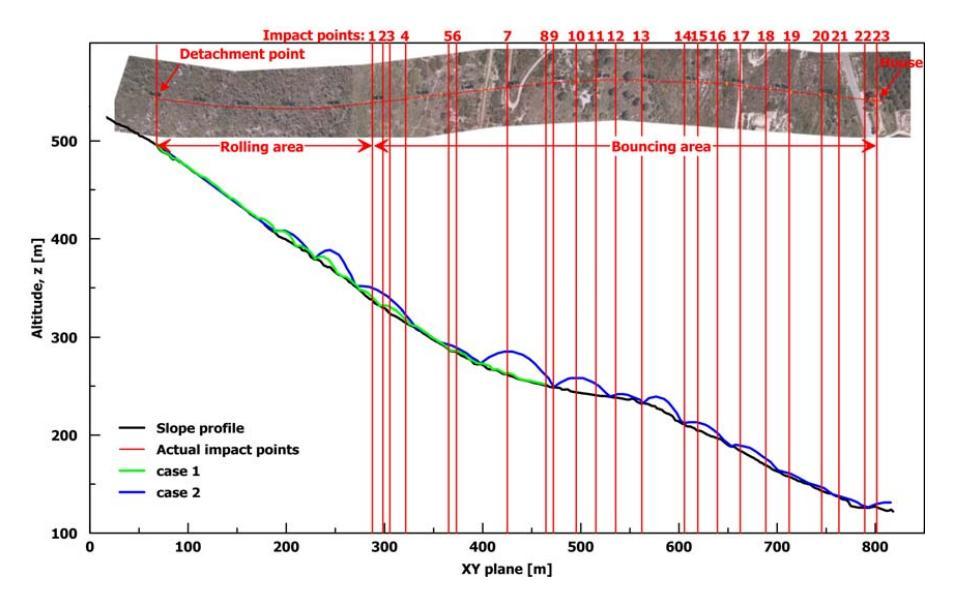
Figure 6. Plan view and cross section along block's path (units in m); 2D rockfall trajectory analysis results are plotted with green and blue line

223 23 impact points were identified on the slope surface (Figure 6). Their coordinates
224 are presented in Table 2, along block's path starting from the detachment point
225 (where x=0).

In this case, the modelled trajectory is significantly different from the actual one. The main difference is that the block is rolling up to 200 m downslope while the actual rolling section is 400 m (as shown in Fig. 6). Furthermore the impacts on the ground in the bouncing section of the trajectory are considerably different in number (14 versus 23) and in location from the actual ones. Finally, the bounce height of some impacts seems unrealistically high.

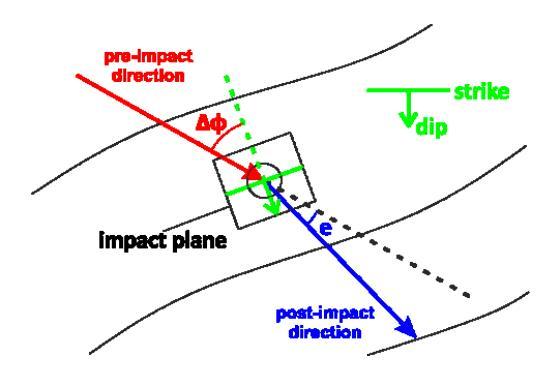
Figure 7 : Out of plane geometry

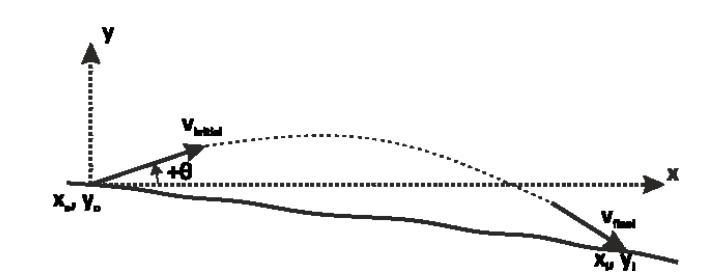
Figure 8. Parabolic segment

where: θ the launch angle from the horizon and v the launch (initial) velocity (Figure8).

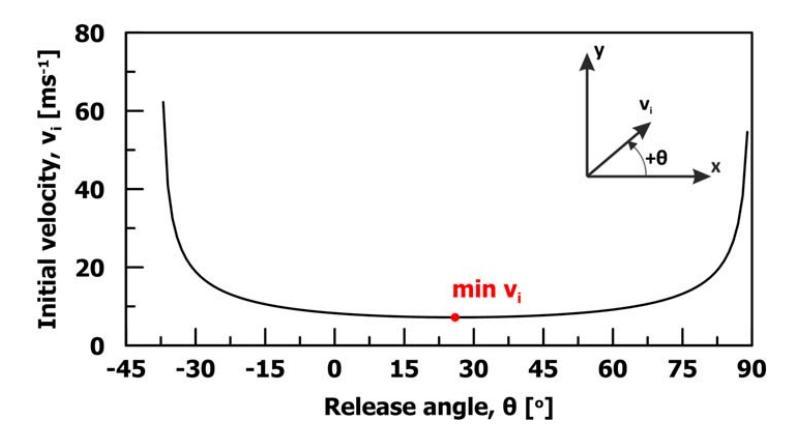
Figure 9. Release angle versus initial velocity for the first parabolic section (δx =10.75m, δy =8.33m)

Since no evidence can be collected regarding launch angle and velocity, innumerable parabolas satisfy Eq. 5. However, θ is bound between $-\beta$ and 90° , so in order to acquire realistic values for the initial velocity, its sensitivity for that given range was addressed (Figure 9).

For the case presented in Fig. 9 (the first parabolic segment) it is seen that for the majority of the release angles, initial velocity variation is low and ranges between 7.2 and 12ms^{-1} . Additionally, the relationship between release angle and initial velocity is expressed by a curvilinear function, thus a minimum initial velocity value along with its release angle (denoted hereafter as θ_{cr}) can be easily acquired.

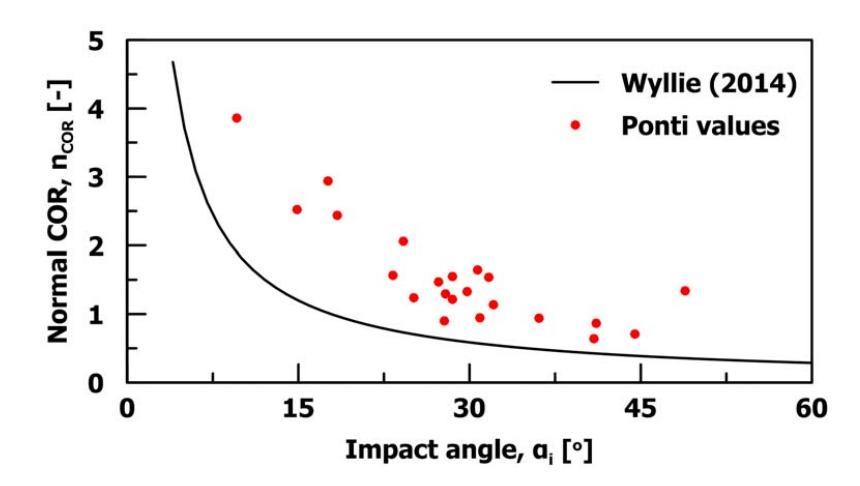
Figure 10. Normal COR versus impact angle

Moreover, it is observed in Fig. 10 that normal COR increases as the impact angle reduces, similarly to previous observations by Giacomini et al. (2012), Asteriou et al. (2012) and Wyllie (2014). The correlation proposed by Wyllie (2014) is also plotted in Figure 11 and seems to describe consistently, but on the unconservative side, the trend and the values acquired by the aforementioned analysis and assumptions.

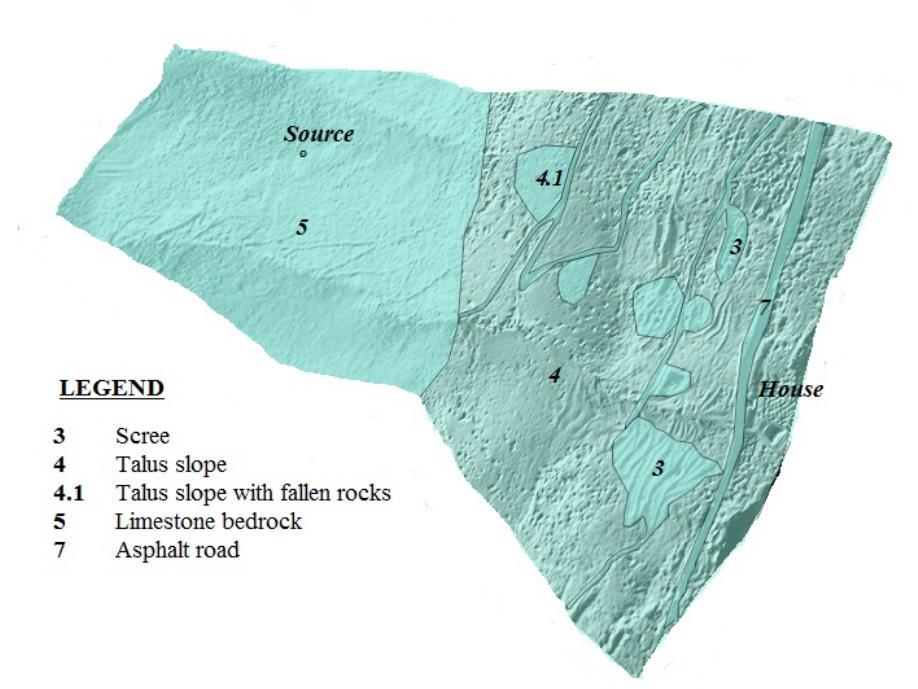
Figure 11. Soil types for 3D rockfall analysis (according to Rockyfor3D)

The 3D analysis was based on the down-scaled 2 m resolution Digital Elevation Model (DEM) that was generated from the 10 cm DSM. The terrain features such as low vegetation (e.g. bushes) and the trees were removed from the DEM as they affected the rock's path downhill. The following raster maps were developed for the 3D analysis: a) rock density of rockfall source, b) height, width, length and shape of block, c) slope surface roughness and d) soil type on the slope, which is directly linked with the normal coefficient of restitution, n_{COR} .

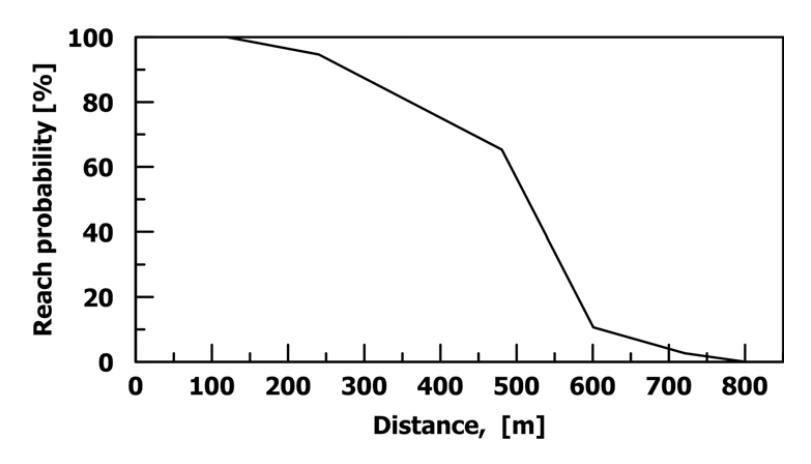
Figure 12. Reach probability graph calculated from 3D rockfall analysis

probability of the falling rocks, initiating from the source point, is shown in Figure 12.

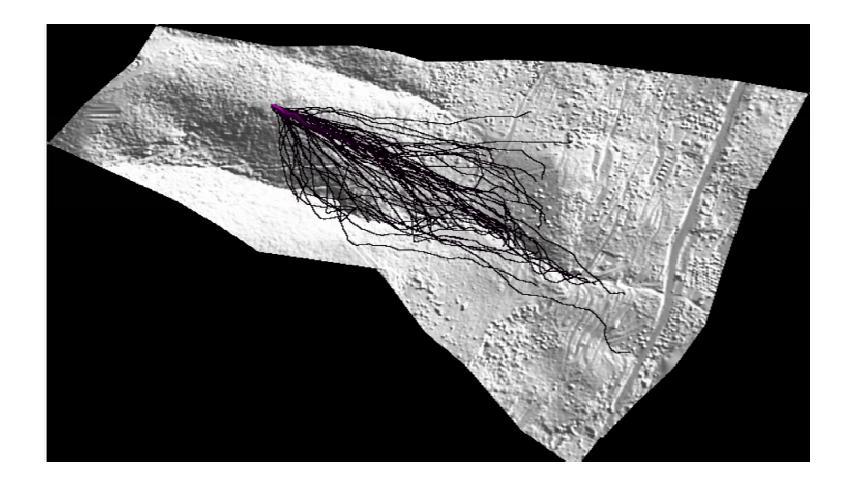
Figure 13. 3D trajectory analysis (from RockyFor3D analysis)

355 Lateral dispersion cannot be defined from the actual rockfall event in Ponti since only 356 one path is available. Using the simulated trajectories from RockyFor3D, which are in 357 the 3d space (Figure 13), a lateral dispersion of approximately 60% is shown in the 358 middle of the distance between detachment point and the house. This is significantly 359 higher compared to the findings of Azzoni and de Freitas (1995) and Agliardi and 360 Crosta (2003). Moreover, based on the actual event and intuition, the lateral dispersion computed by RockyFor3D is extremely pronounced. Examining Figure 13, 361 362 it is notable that the rock paths are severely affected by the topography factors. 363 Therefore, assessing lateral dispersion seems to be a case specific task.

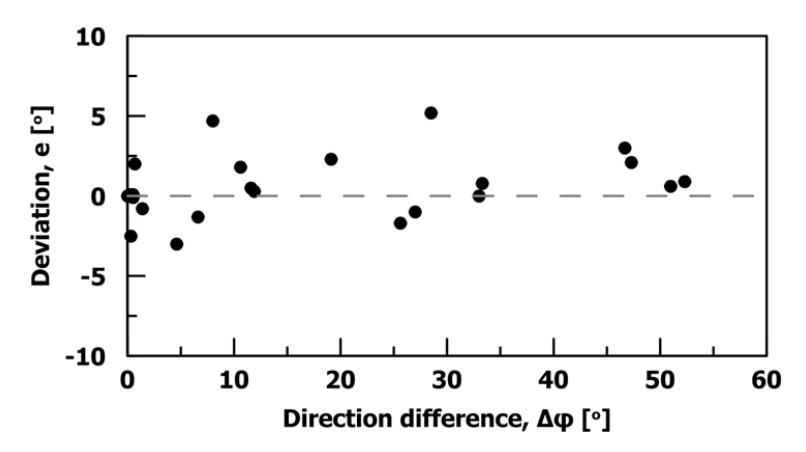
Figure 14. Deviation as a function of direction difference.

372 Figure 14 presents deviation as a function of direction difference. It is noted that for 373 parallel impacts deviation is also equally distributed along the post-impact direction. 374 As direction difference increases, deviation becomes positive, which means that the 375 change of direction is following the direction of slope's aspect. These finding are in 376 line with trends described by Asteriou & Tsiambaos (2016), but the deviation of the 377 actual trajectory is significantly lower. This can be attributed to the different 378 conditions (i.e. block shape, slope material, slope roughness, incident velocity and 379 angle, and scale) between the experimental program conducted by Asteriou & 380 Tsiambaos (2016) and the Ponti rockfall event.
